PINE64

ROCKPro64 Engineering Change Notice

ECN:20180628RP01

This ECN applies strictly to ROCKPro64 Board ver. 2.0, dated 2018-04-11. It is applicable to boards with both 2GB and 4GB memory.

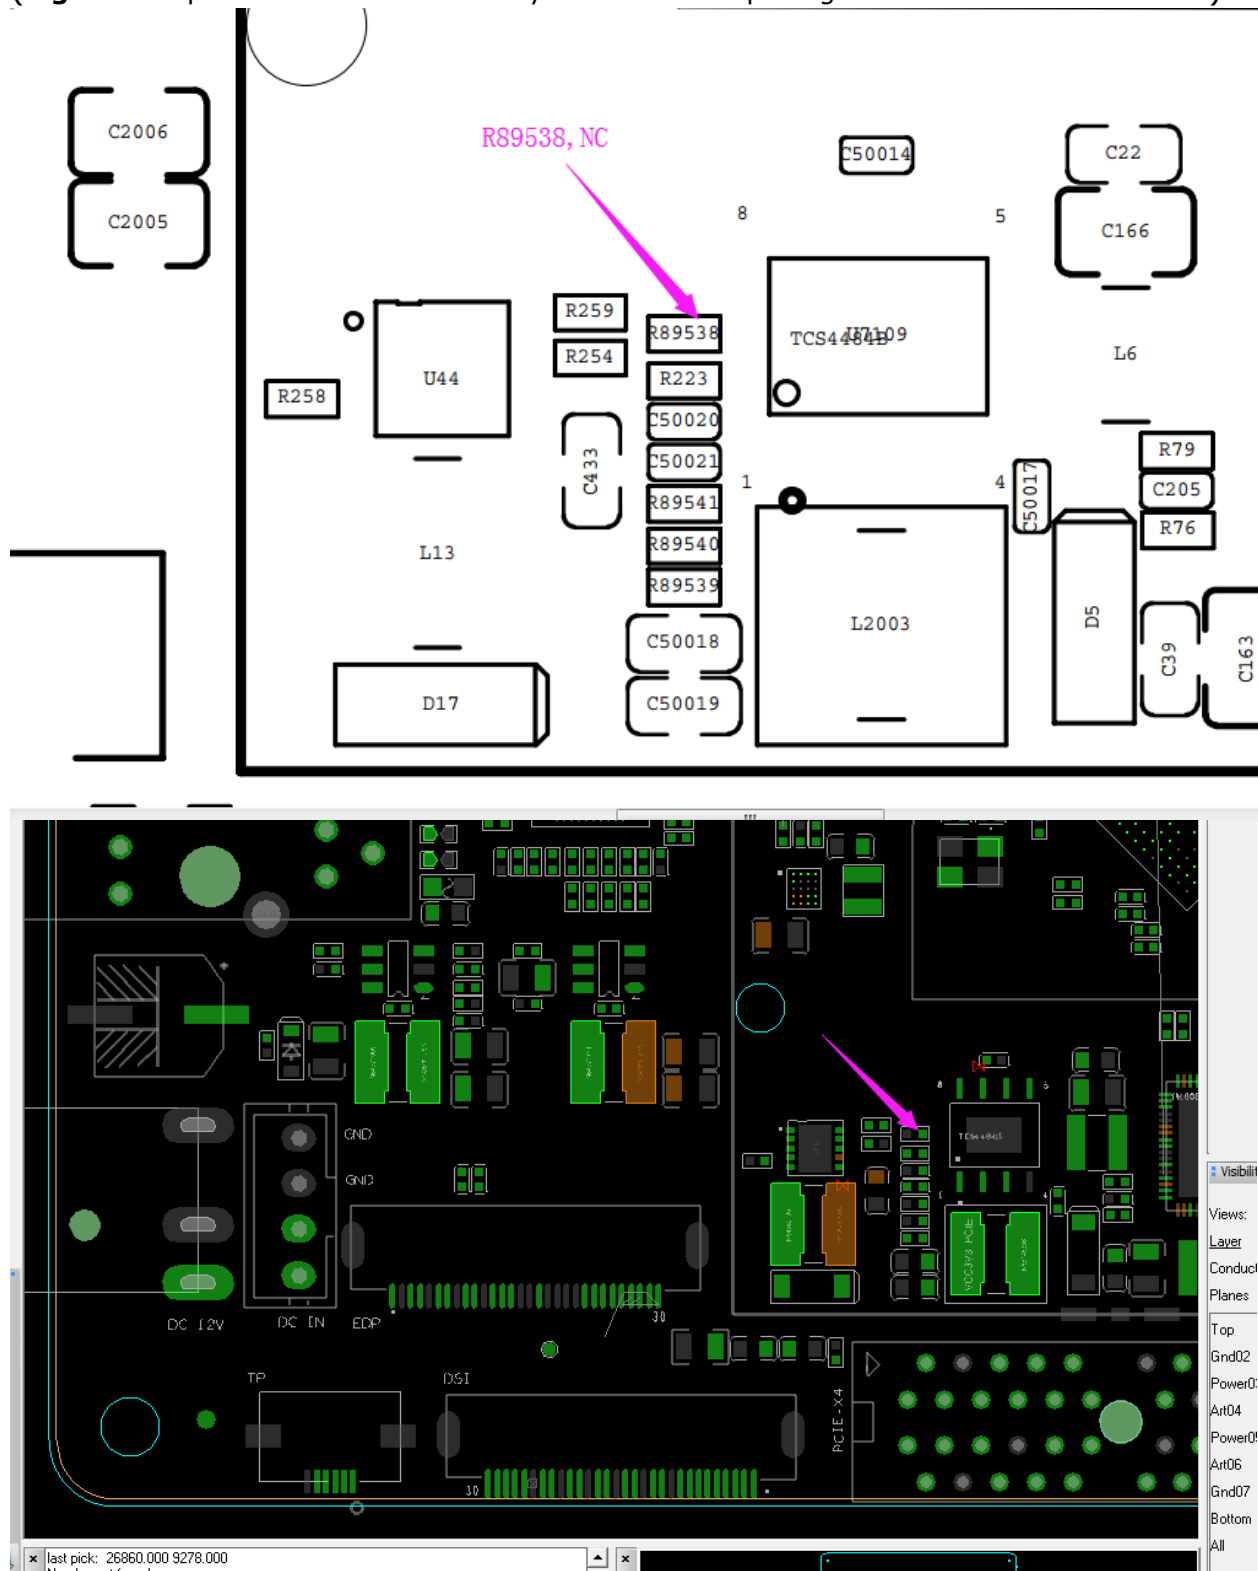
Issue: The PCIe 3.3V power is not supplied; in result PCIe is not functional.

(Fig. 1. Component Schematic and Layout extracts depicting location of R89538 resistor)

Solution: Remove R89538 resistor that affects U7109 TCS4484B power regulator, supplying 3.3V to the PCIe Bus.

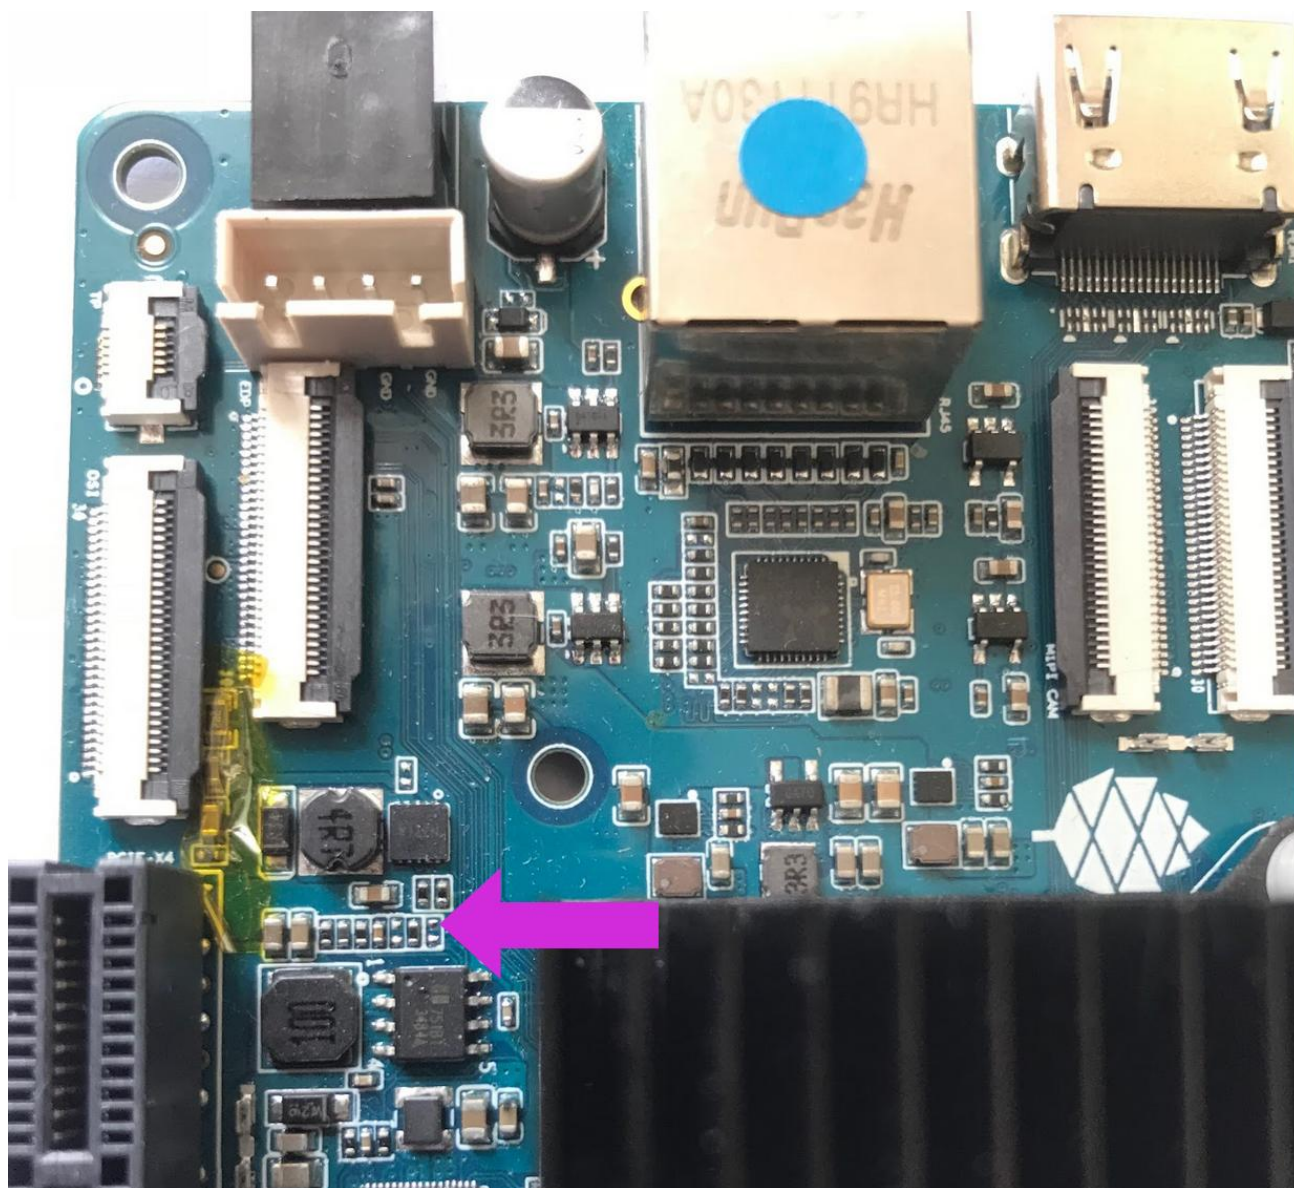
(Fig. 2. Photo of the R89538 resistor on the ROCKPro64 board; resistor removed in photo)
